A CASE STUDY OF FEEDWATER HEATER LIFE MANAGEMENT

The life management case study presented in this paper focuses on KCPL's LaCygne power plant, Unit #2, first point extraction, high pressure feedwater heater #21. LaCygne Unit #2 is a 630 MW generating unit which was upgraded to 710 MW in 1991. Feedwater heater #21 is a three-zone horizontal hemi-head heater containing 1568 u-tubes constructed of SA-556 C2 carbon steel.

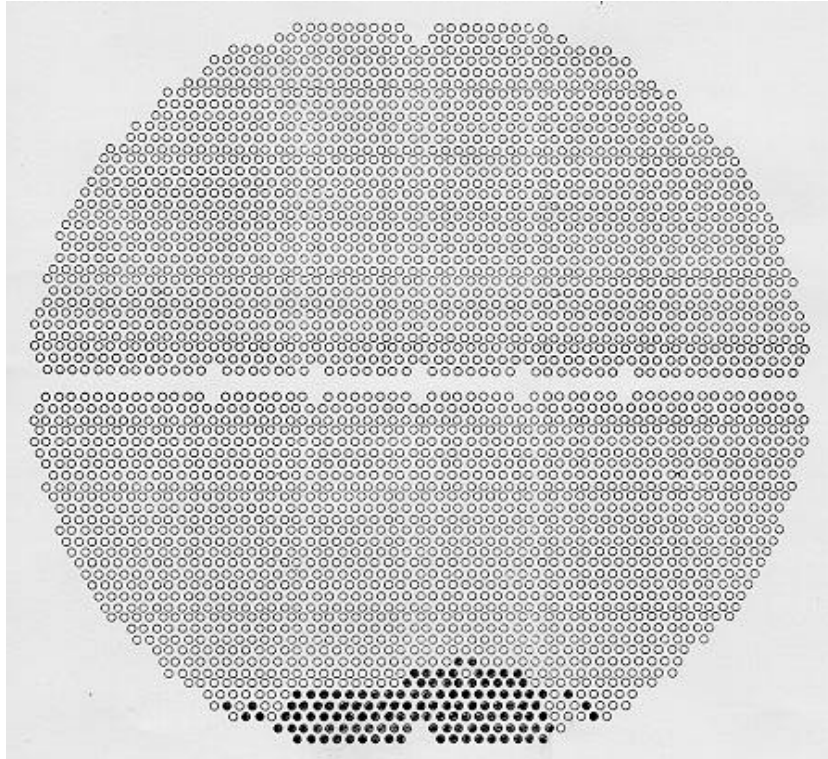
In August, 1990, 13 tubes failed in the lower periphery of the drain cooler region. These 13 tubes were plugged and due to the excessive number of previous failures in this region, 49 additional tubes were insurance plugged at the same time. Figure 2 gives a plug map for feedwater heater #21 which illustrates the 128 tubes which had been plugged in the drain cooler zone as of August, 1990. By the end of 1990, feedwater heater #21 had experienced two more outages due to the failure of 10 more tubes in the drain cooler region. By the end of 1990, 138 tubes had been plugged out of 1568 total tubes. Table 2 summarizes the tube failures experienced by feedwater heater #21 during the period April, 1988 through January, 1991.

FIGURE 2. LA CYGNE UNIT #2, FEEDWATER HEATER #21 TUBE PLUG MAP AS OF AUGUST, 1990, 128 TUBES PLUGGED

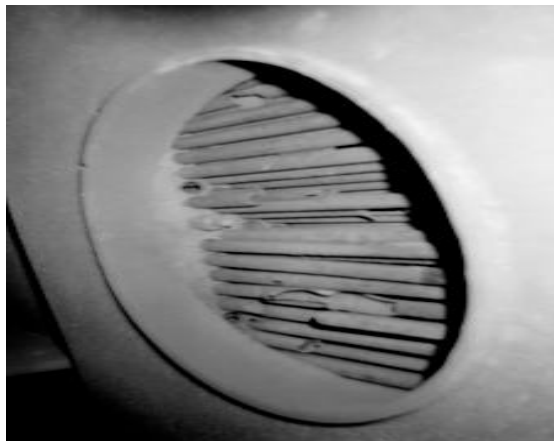
**FIGURE 3. TUBE DAMAGE IN THE DRAIN COOLER ZONE OF LA CYGNE UNIT #2,
FEEDWATER HEATER #21**

During the 1991 retube period while the lower nine rows of u-tubes were removed, a close inspection was made of the remaining tubes, baffles and end plate. This inspection revealed only minor pitting. The drain cooler zone end plate holes and baffles were inspected and no erosion was found. The remaining tubes adjacent to the retube area were hydrostatically tested and found to be acceptable. At the completion of the 1991 retube project, six tubes remained plugged in feedwater heater #21.

Therefore, during the period February, 1991 to April, 1991, 219 u-tubes were replaced in feedwater heater #21 in the area directly above the drain cooler inlet riser. This riser was an early design which utilized a round pipe instead of the square inlet design which is currently used. It was determined that a standing vortex emanating from the round inlet riser had eroded the tubes in this vicinity. This problem was identified and resolved during the 1991 retube by inserting a one inch bar across the diameter of the inlet riser. Figure 3 illustrates the type of tube damage found in the drain cooler zone of LaCygne Unit #2, feedwater heater #21 during the 1991 retube project.

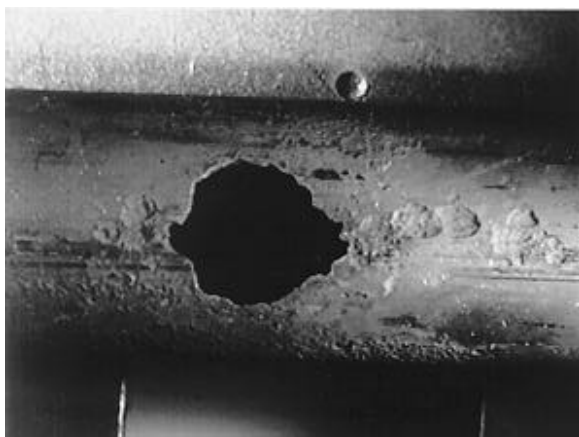
In mid-July of 1990, two more tubes failed in the drain cooler region near the baffle plate separating the drain cooler from the condensing zone. One of these tubes was removed and examined with a stereo microscope. No damage other than the single failure was noted. This single failure exhibited a profile consistent with an erosion/corrosion failure. The failure area of the tube was metallurgically examined and no problems were noted in the tube microstructure. A large amount of corrosion was present and pitting was noted on the outside of the tube. It was hypothesized that turbulent steam flow near the baffle plate was eroding and pitting the tube surface, with corrosion compounding the problem. Yokell (1995) states that uncondensed saturated steam entering the drain cooler zone, through the annular spaces between the holes in the end plate and the tubes, leads to the erosion of the holes in the end plate and baffles. This steam then condenses within the drain cooler zone resulting in an implosion effect which causes localized pitting on the outside surface of the tubes.

**OUTSIDE SURFACE OF THE ORIGINAL,
16 YEAR OLD TUBE SAMPLE.**

**FIGURE 4. LOCALIZED PITTING AND
WALL FAILURE FOUND ON THE**

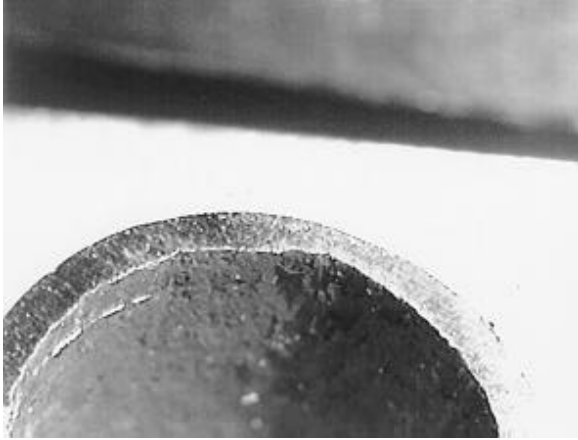
FIGURE 5. CORROSION FOUND ON THE INSIDE SURFACE OF THE ORIGINAL, 16 YEAR OLD TUBE SAMPLE.

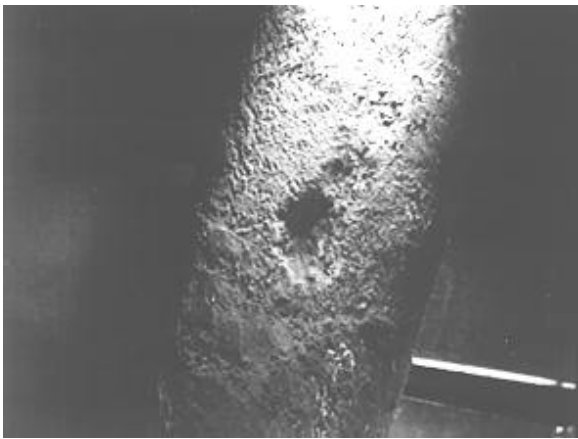
FIGURE 6. PIT FOUND ON THE OUTSIDE SURFACE OF THE RETUBE SAMPLE.

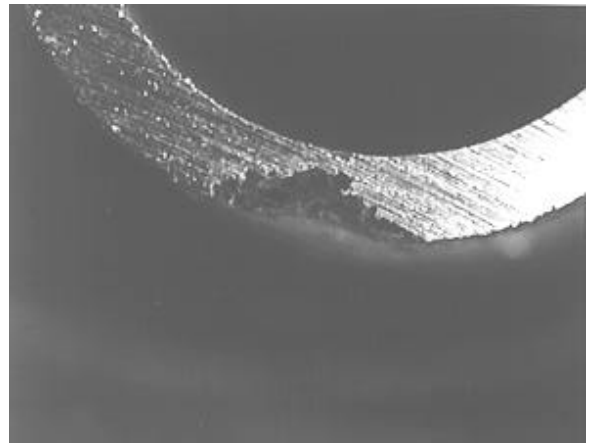
FIGURE 7. CROSS SECTION OF PIT ON RETUBE SAMPLE.

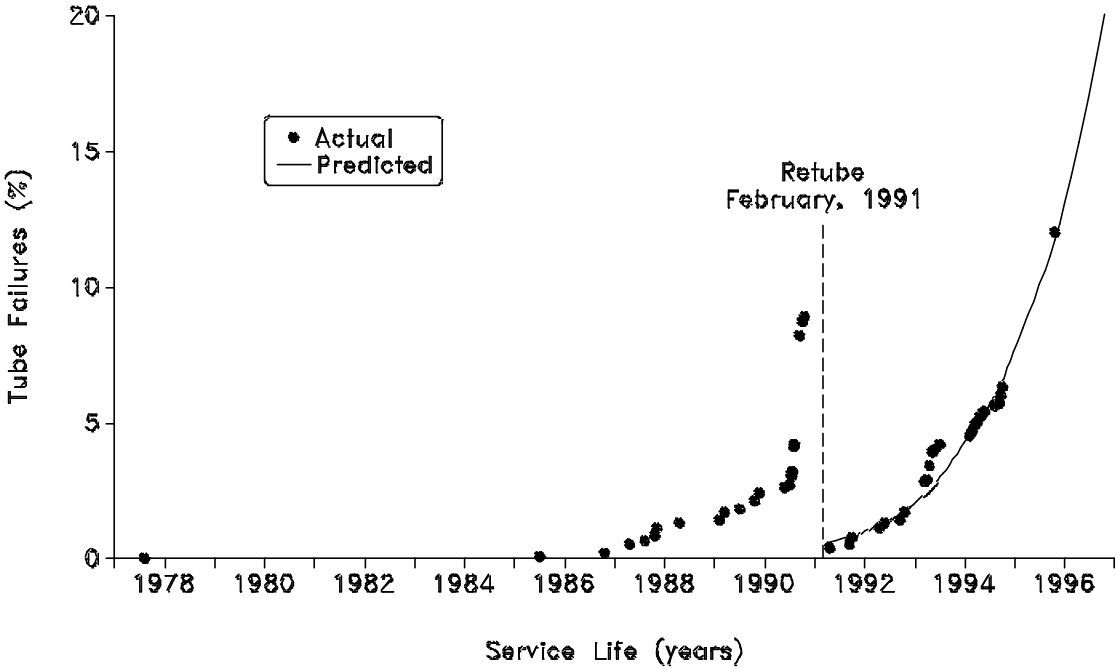
During the next 16 months, feedwater heater #21 was out of service 14 times due to tube leaks resulting in 37 additional u-tubes being plugged. At this time, the useful life of the feedwater heater was predicted by using an exponential function to fit the tube failure data. As shown in Figure 8, this prediction indicated that 10% of the tubes would be out of service by September of 1995. During the period August, 1994 to September, 1995, 86 additional tubes were plugged. Figure 9 gives the final plug map for feedwater heater #21 as of September, 1995. It illustrates the 184 plugged tubes, 12% of the 1568 total tubes. Table 3 summarizes the tube failures experienced by feedwater heater #21 during the period from February, 1991 through September, 1995.

FIGURE 8. ACTUAL AND PREDICTED TUBE FAILURES FOR FEEDWATER HEATER #21

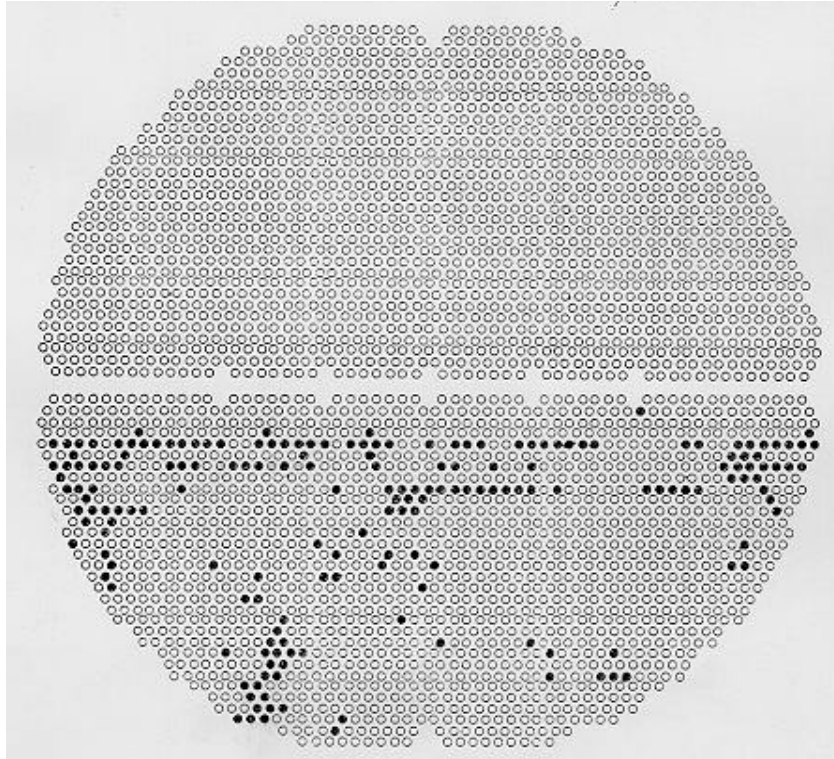
FIGURE 9. LA CYGNE UNIT #2, FEEDWATER HEATER #21 FINAL TUBE PLUG MAP, 184 TUBES PLUGGED
