A CASE STUDY OF FEEDWATER HEATER LIFE MANAGEMENT

The life management case study presented in this paper focuses on KCPL's LaCygne power plant, Unit #2, first point extraction, high pressure feedwater heater #21. LaCygne Unit #2 is a 630 MW generating unit which was upgraded to 710 MW in 1991. Feedwater heater #21 is a three-zone horizontal hemi-head heater containing 1568 u-tubes constructed of SA-556 C2 carbon steel.

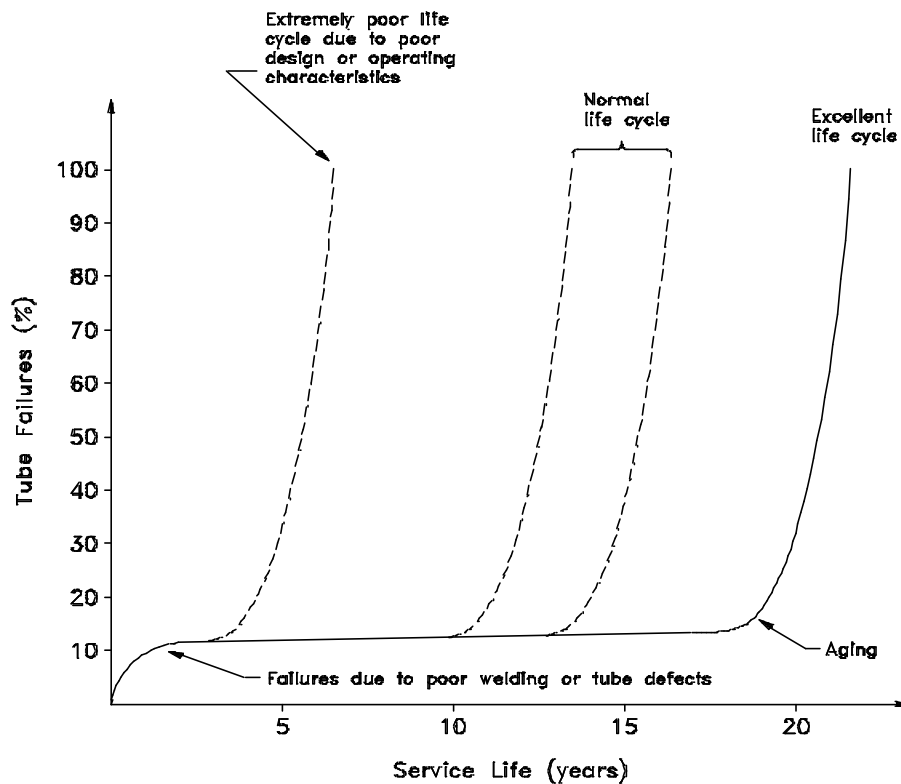
As illustrated in Figure 1, the tube failure rate in a feedwater heater increases exponentially with age. Therefore, to reduce the potential for costly maintenance, it is imperative to predict when the tube failure rate will enter the steep portion of the curve. This prediction will provide lead time to plan for the replacement or refurbishment of the feedwater heater. Prediction is accomplished by fitting an exponential growth function to the feedwater heater's historical tube failure data.

FIGURE 1. LIFE CYCLE OF A HIGH PRESSURE, CARBON STEEL TUBED FEEDWATER HEATER (BELL ET AL., 1991)
